#### § 215.121 Defective car body.

# 49 CFR Ch. II (10-1-13 Edition)

### § 215.123 Defective couplers.

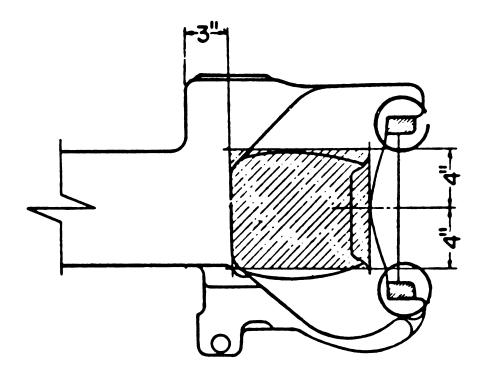
# Figure 2

- (a) The car is equipped with a coupler shank that is bent out of alignment to the extent that the coupler will not couple automatically with the adjacent car.
- (b) The car has a coupler that has a crack in the highly stressed junction area of the shank and head as shown in the figure below (see figure 2).
- (c) The car has a coupler knuckle that is broken or cracked on the inside pulling face of the knuckle.
- (d) The car has a knuckle pin or knuckle thrower that is:
  - (1) Missing; or
- (2) Inoperative; or
- (e) The car has a coupler retainer pin lock that is—  $\,$
